CLIENT Wentworth Shire Council
PROJECT Buronga Landfill Expansion Detailed Design
LOCATION Wentworth, NSW

PROJECT NO. 202597

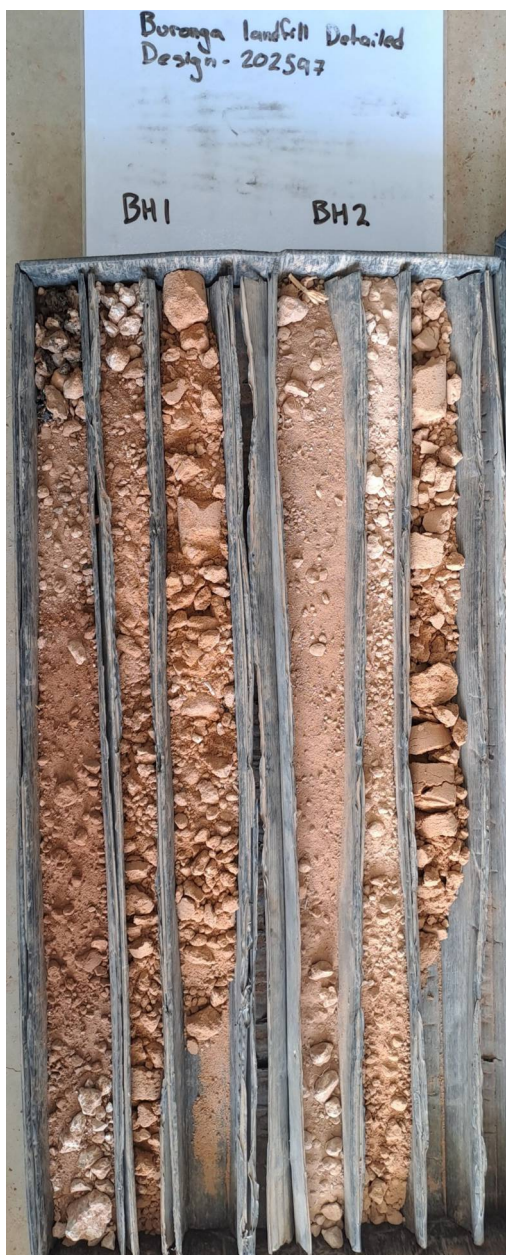
PHOTOS

43.0	0.4											
42.8	0.6											
42.6	0.8		SC	D	MD	Calcareous Clayey SAND. Fine to coarse grained, white, low plasticity fines, trace fine to medium grained gravels, sub-rounded

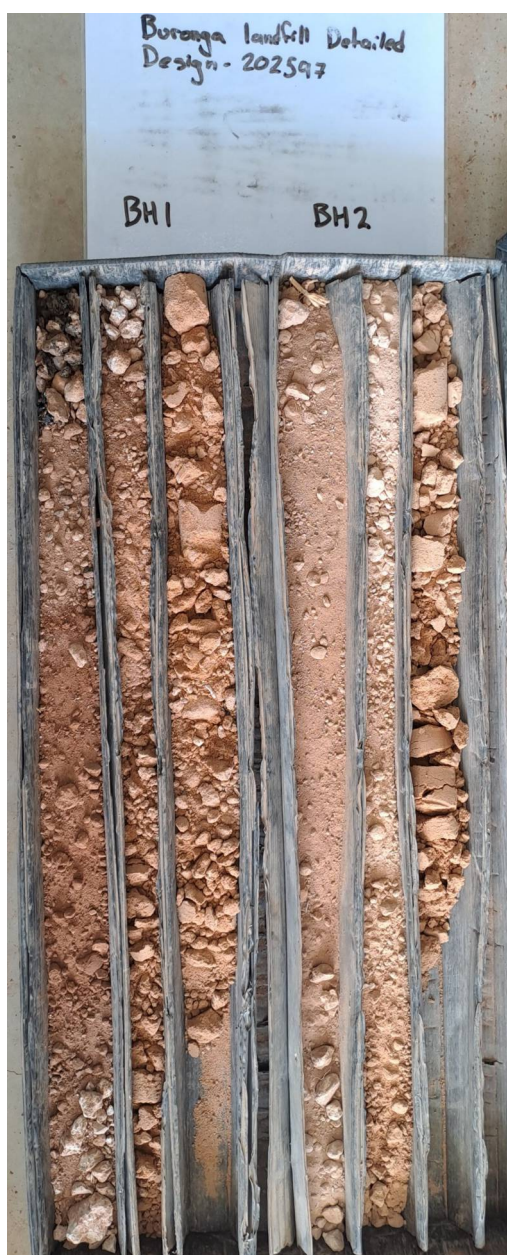
PHOTOS

SC	D	L MD	Calcareous Clayey SAND. Fine to coarse grained, pale brown and white, low plasticity fines, with fine to medium grained gravels, sub-rounded to sub-angular

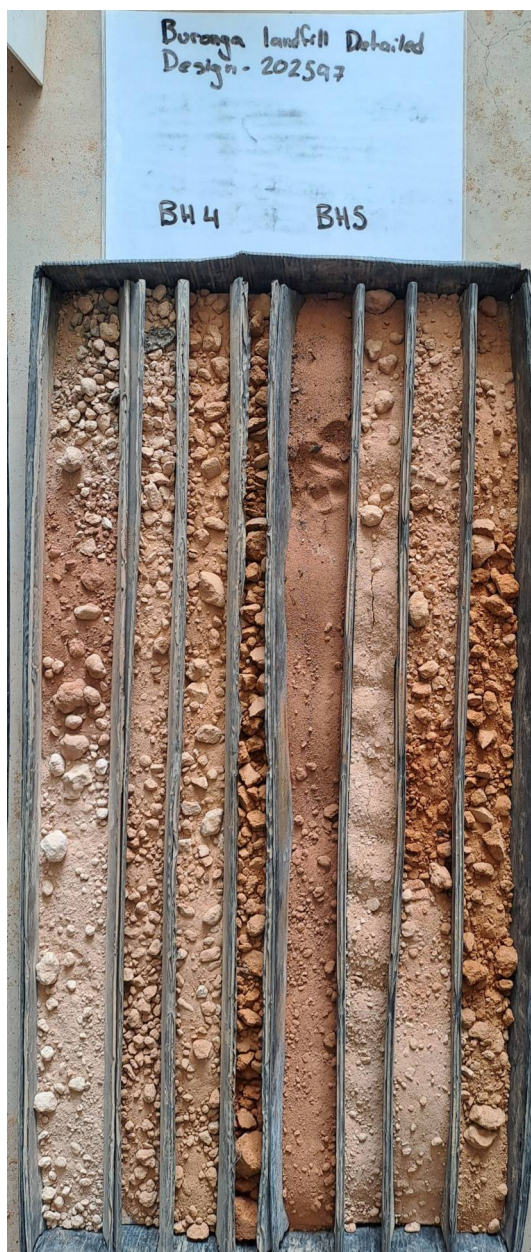
PHOTOS

45.8	0.2		-	D	MD	FILL. Calcareous sandy gravel, fine to medium grained, sub-rounded to angular, asphalt inclusions, with low plasticity fines				
45.6	0.4		SP	D	MD	Calcareous SAND. Fine to coarse grained, pale brown, with low plasticity fines, trace fine grained gravels

45.4	0.6		SC	D	MD	Calcareous Clayey SAND. Fine to coarse grained, white, with fine to coarse grained gravels, sub-rounded to sub-angular, becoming pale brown with depth

45.2	0.8									
45.0	1.0									
44.8	1.2									
44.6	1.4									
44.4	1.6									
44.2	1.8									
44.0	2.0									
43.8	2.2		SC	D	MD	Clayey SAND. Fine to coarse grained, orange-brown, low plasticity fines, trace fine grained gravels

43.6	2.4									
43.4	2.6									
43.2	2.8									
43.0	3.0		CL	w<PL	Fb	Sandy CLAY. Low plasticity, orange-brown, fine to coarse grained, trace fine grained gravels				
						End of hole at 3.0 m, target depth reached

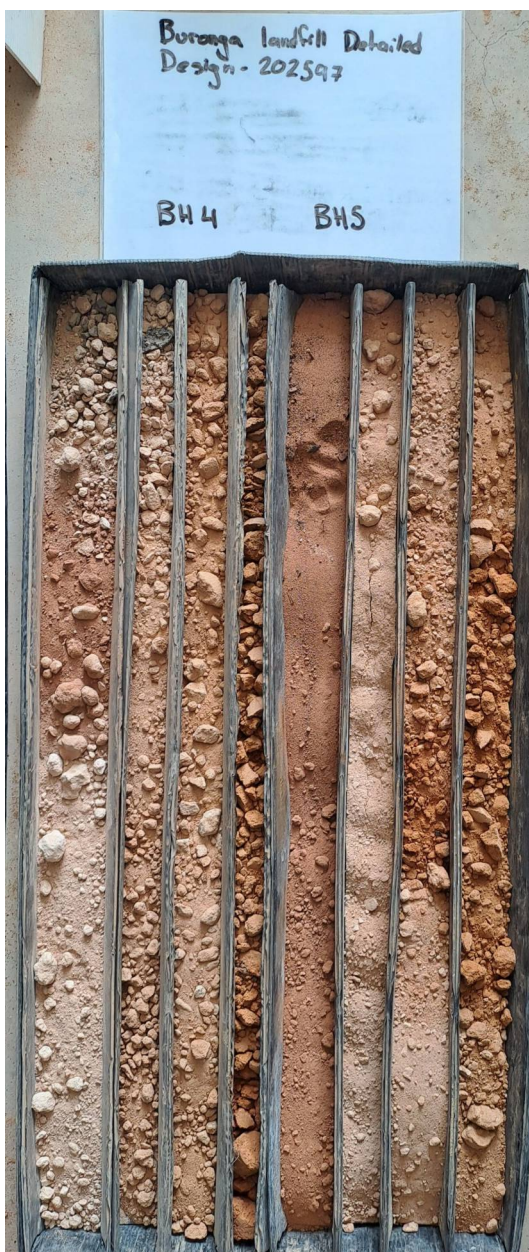
PHOTOS

SC	D	L MD	Calcareous Clayey SAND. Fine to coarse grained, poorly graded, pale brown, low plasticity fines, with fine to medium grained gravels, sub-angular to sub-rounded, organics to 200 mm depth

47.1	0.4										
46.9	0.6										
46.7	0.8										
46.5	1.0										
46.3	1.2	SC	D	L MD	Calcareous Clayey SAND. Fine to coarse grained, poorly graded, white, low plasticity fines, with fine to coarse grained gravels, becoming trace gravels from 0.9 mBGL

46.1	1.4										
45.9	1.6										
45.7	1.8										
45.5	2.0										
45.3	2.2	SC	D	MD	Clayey SAND. Fine to coarse grained, orange-brown, low plasticity fines, trace fine grained gravels

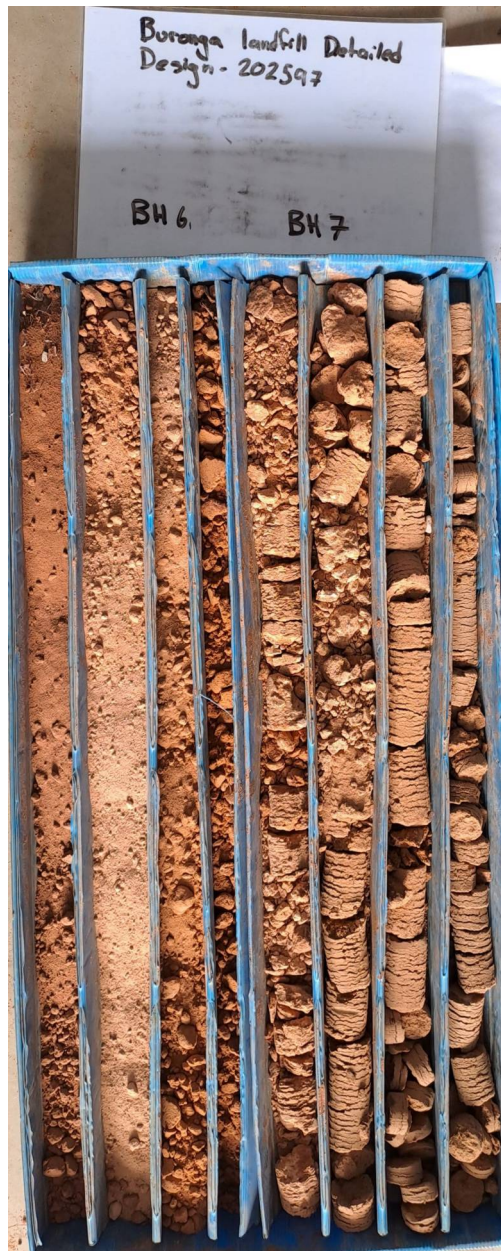
PHOTOS

USCS CLASS. SC CI CL		MOISTURE D w<PL w<PL w<PL w<PL w<PL w<PL w<PL w<PL w<PL w<PL w<PL w<PL w<PL w<PL			DENSITY/CONSISTENCY MD Fb Fb Fb Fb Fb Fb Fb Fb Fb Fb Fb Fb Fb Fb Fb		DESCRIPTION AND OBSERVATIONS Calcareous Clayey SAND. Fine to coarse grained, poorly graded, pale brown, low plasticity fines, with fine to medium grained gravels, sub-angular to sub-rounded, organics throughout Calcareous Sandy CLAY. Medium plasticity, brown and white, black flecking, fine to coarse grained sands, trace fine grained gravels. CLAY. Medium plasticity, grey with brown mottling, with fine to coarse grained sands, minor calcareous white pockets Sandy CLAY. Low to medium plasticity, pale brown with minor grey mottling, fine to coarse grained sands End of hole at 3.0 m, target depth reached		SAMPLE 		SAMPLE TYPE/ID 		IN-SITU TESTING 		COMMENTS/OBSERVATIONS Inferred to be in situ as a mixture of cobbles and calcareous clayey sand per TP01, but recovery from borehole as per description.

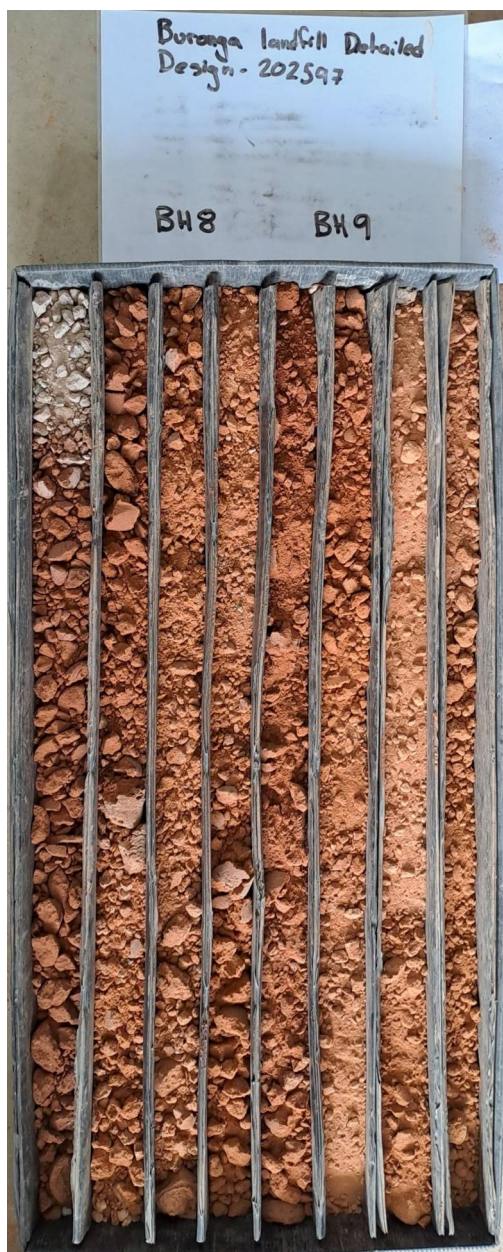
PHOTOS

SC	D	MD D	Clayey SAND. Fine to coarse grained, red-brown, low plasticity fines, grades to with clay in places.					
45.9	0.4		SC	D	MD	Clayey SAND. Fine to coarse grained, orange-brown, low plasticity fines, trace fine grained gravels, lenses grade to Sandy CLAY

45.7	0.6										
45.5	0.8										
45.3	1.0										
45.1	1.2	SC	D	MD	Calcareous Clayey SAND. Fine to coarse grained, poorly graded, pale brown to white, low plasticity fines, with fine to medium grained gravels, sub-angular to sub-rounded

44.9	1.4										
44.7	1.6										
44.5	1.8	SP	D	MD	SAND. Fine to coarse grained, poorly graded, orange brown to orange and red-brown, with low plasticity fines grading to clayey in places, trace fine to medium grained gravels

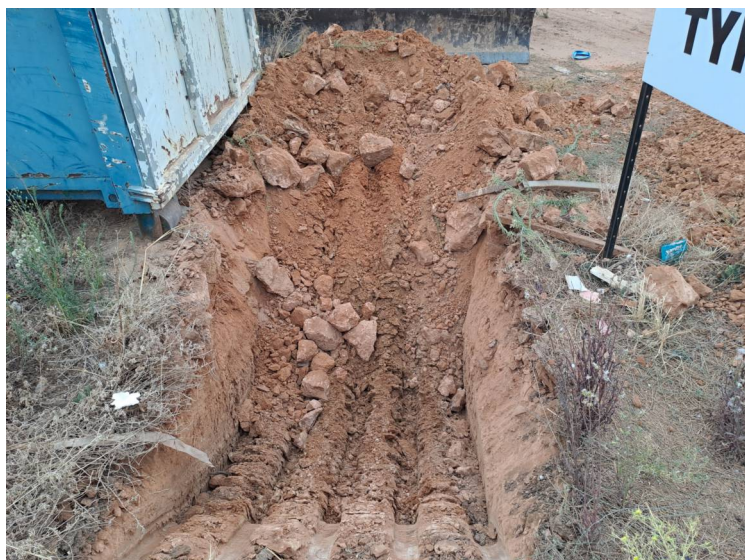
PHOTO / SKETCH

Located in drop off area

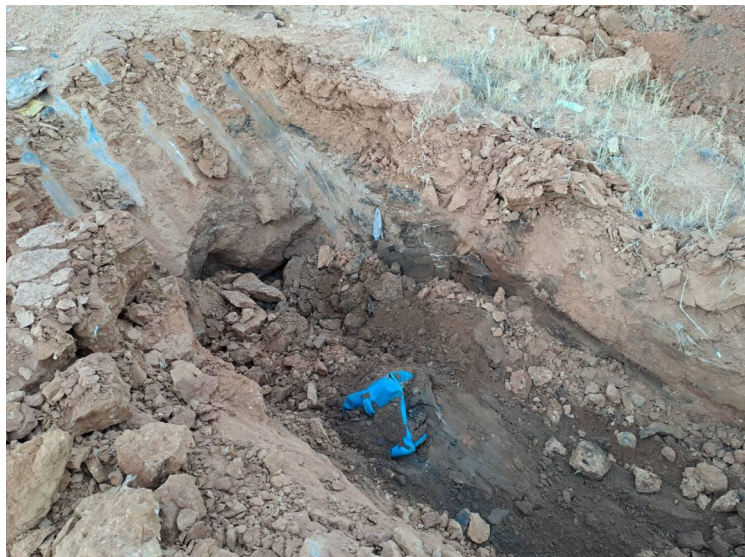
PHOTO / SKETCH

Edge of exiting landfill

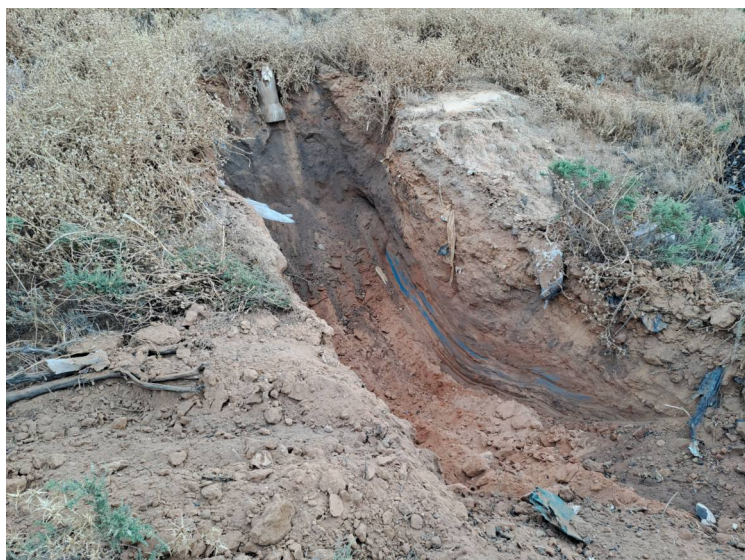
PHOTO / SKETCH

Edge of exiting landfill

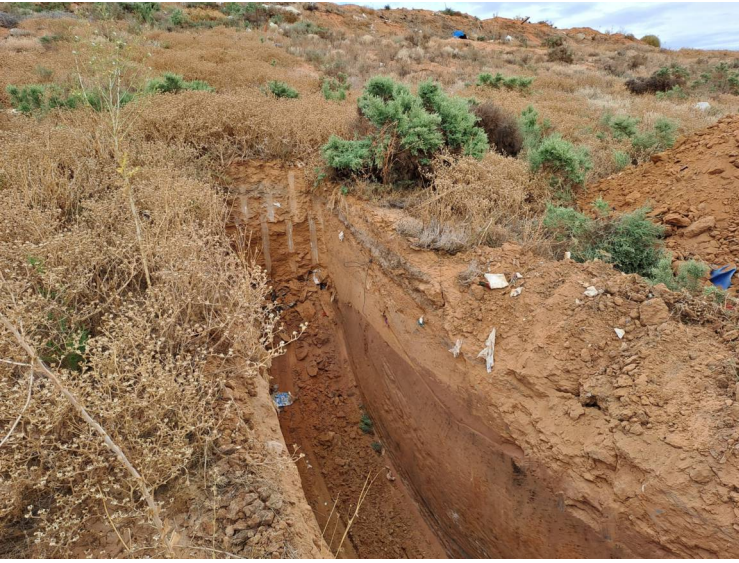
39.4	0.2		-	D	MD	FILL. Sand, fine to coarse grained, poorly graded, grey, trace low plasticity fines, organics throughout					
39.3	0.3		-	D	MD	FILL. Calcareous clayey sand, pale brown and orange, low plasticity, with fine to coarse grained gravels, waste inclusions

39.2	0.4										
39.1	0.5										
39.0	0.6										
38.9	0.7										
38.8	0.8										
38.7	0.9		-	-	-	Waste. Mixed, plastic bags, chip packets, plastics, cardboard.					
					End of hole at 1.0 m. Waste encountered.						
<div> <div> <div>PHOTO / SKETCH</div>

</div> <div> <div>ADDITIONAL NOTES</div> <div>Edge of exiting landfill</div> </div> </div>											
PROJECT NO. 202597										PAGE 1 OF 1
