# Buronga Landfill Expansion

Amendment Report

#### Wentworth Shire Council

SSD-10096818 8 February 2023 Ref: 202597R07

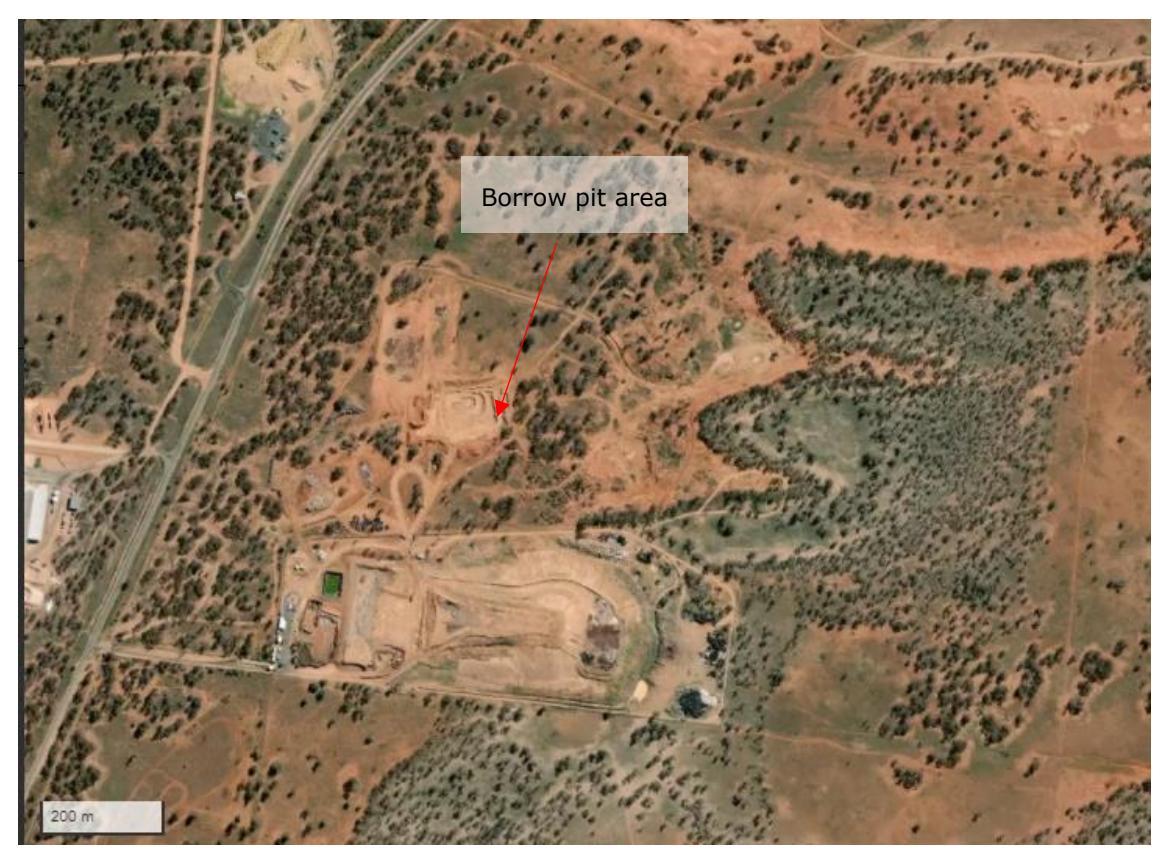
Figure 1 LIDAR Image of Buronga Landfill (Source: MetroMap)

The borrow pit has targeted already cleared areas to the north of the landfill (Figure 1). A haul road has been provided for safe access as recommended in the SEE. Topsoil has been stripped from the eastern side of the borrow for use as daily cover. The deeper pit was used to extract clay for construction of the current landfill cell. The heritage item was located to the south of the deeper excavation, further discussion on this item is provided in Section 8.7.

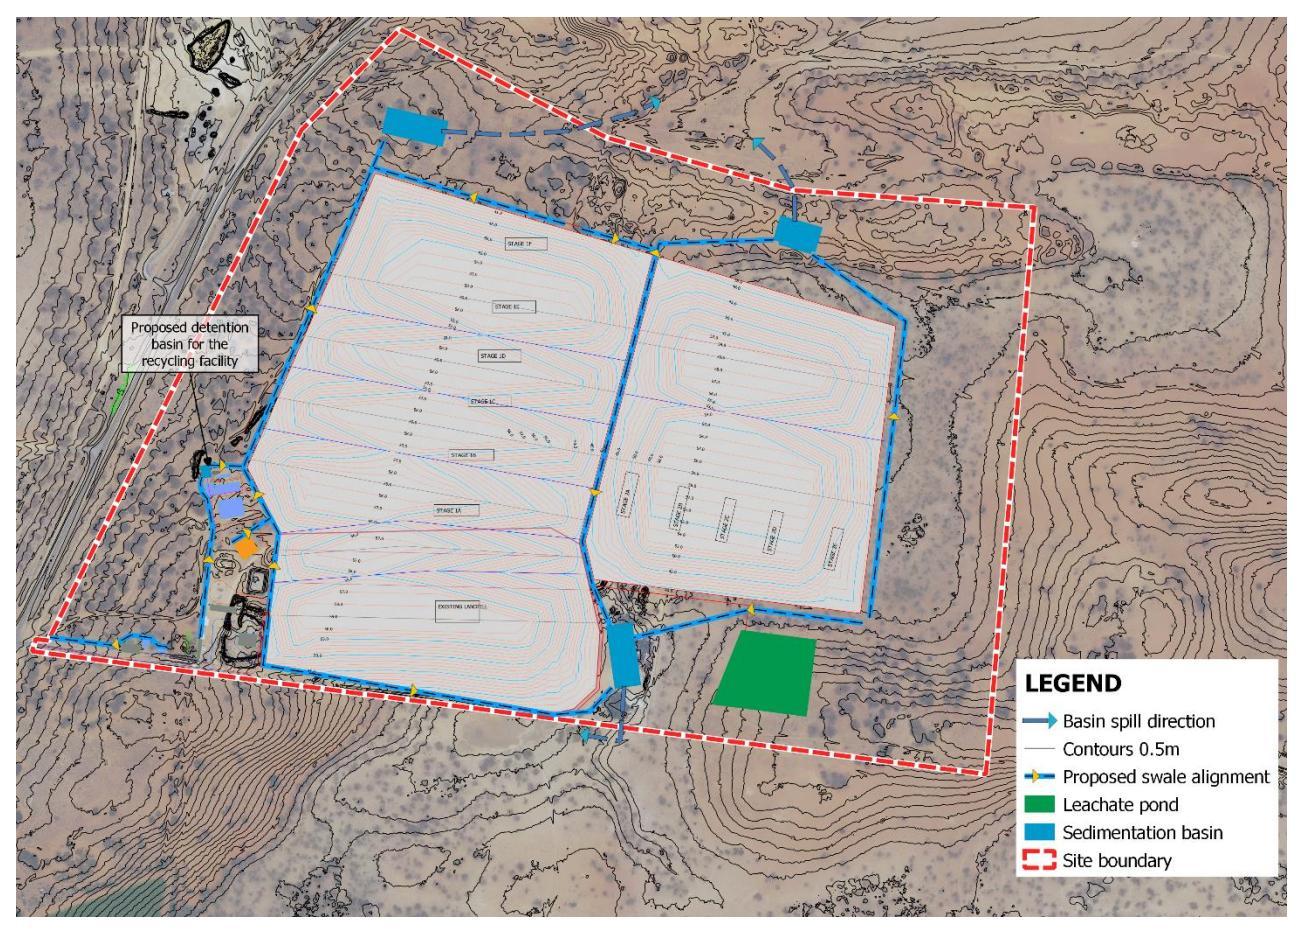
#### Figure 6 Drainage Plan

It should be noted that the sizing of the grass-lined swales as well as the swale surface treatment is to be finalised during detailed design. The concept drainage plan showing the proposed alignment of the grass-lined swales is provided in Figure 6.

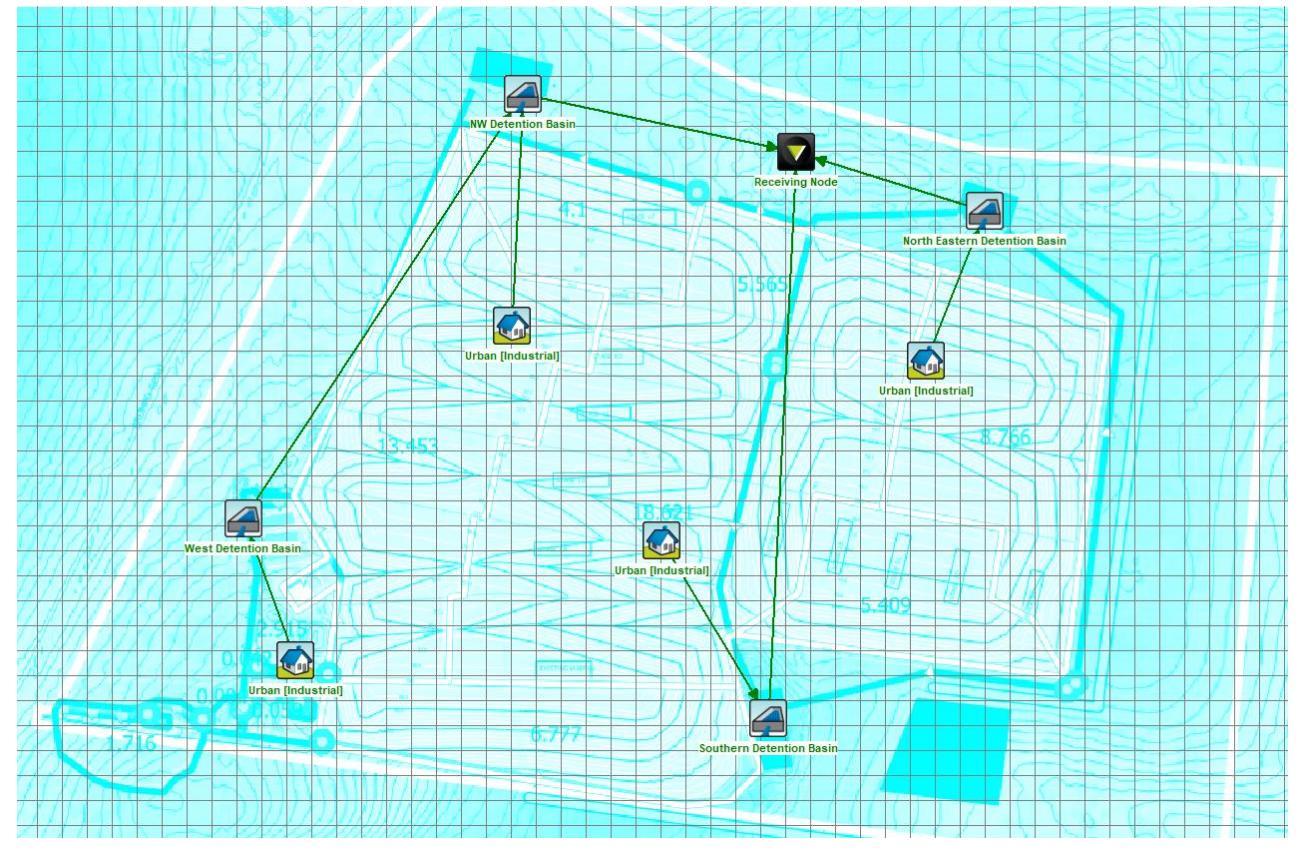
Using the catchment plan shown in Figure 5, lumped catchments were configured for all the capped landfill areas in MUSIC for the generation of runoff into each sedimentation basin. Given the presence of the impervious liner for each of the landfill caps, groundwater seepage was ignored. Also, the soil storage capacity and field capacity for the lumped catchments draining towards the sedimentation basins were modified based on the rehabilitated state of the landfill caps. This resulted in an approximate rainfall-runoff ratio of 0.15. It should be noted that water reuse for activities such as dust suppression, truck washdowns, and toilet flushing, were not considered as part of the water balance modelling conducted.

The configuration of the MUSIC model is shown in Figure 7 below.

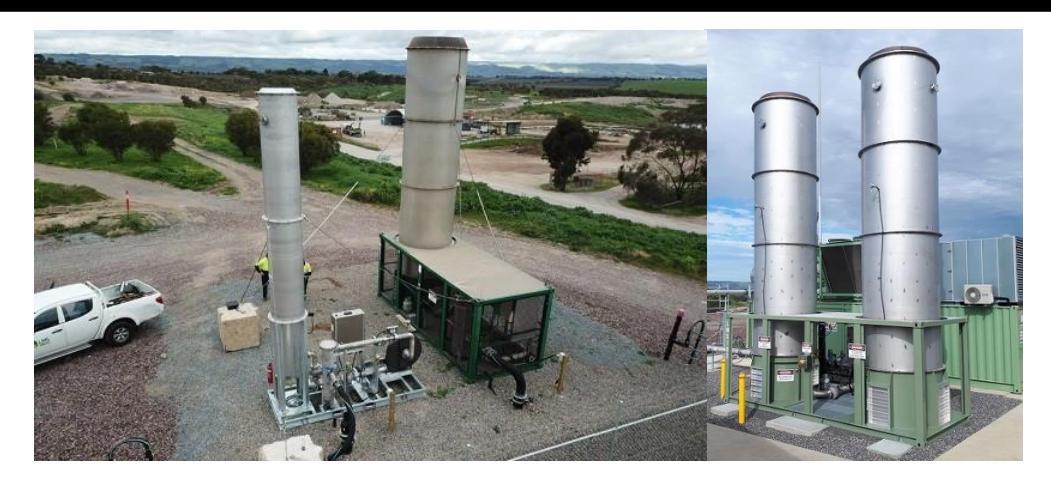
## LMS GAS FLARE

The LMS Gas Flare provides Australia's most proven flare for the clean combustion of landfill biogas. LMS have engineered this technology by drawing on more than 35 years of biogas combustion experience. LMS flares have been purpose built for the landfill environment and their performance in terms of total carbon abated from Australian landfills is unmatched.

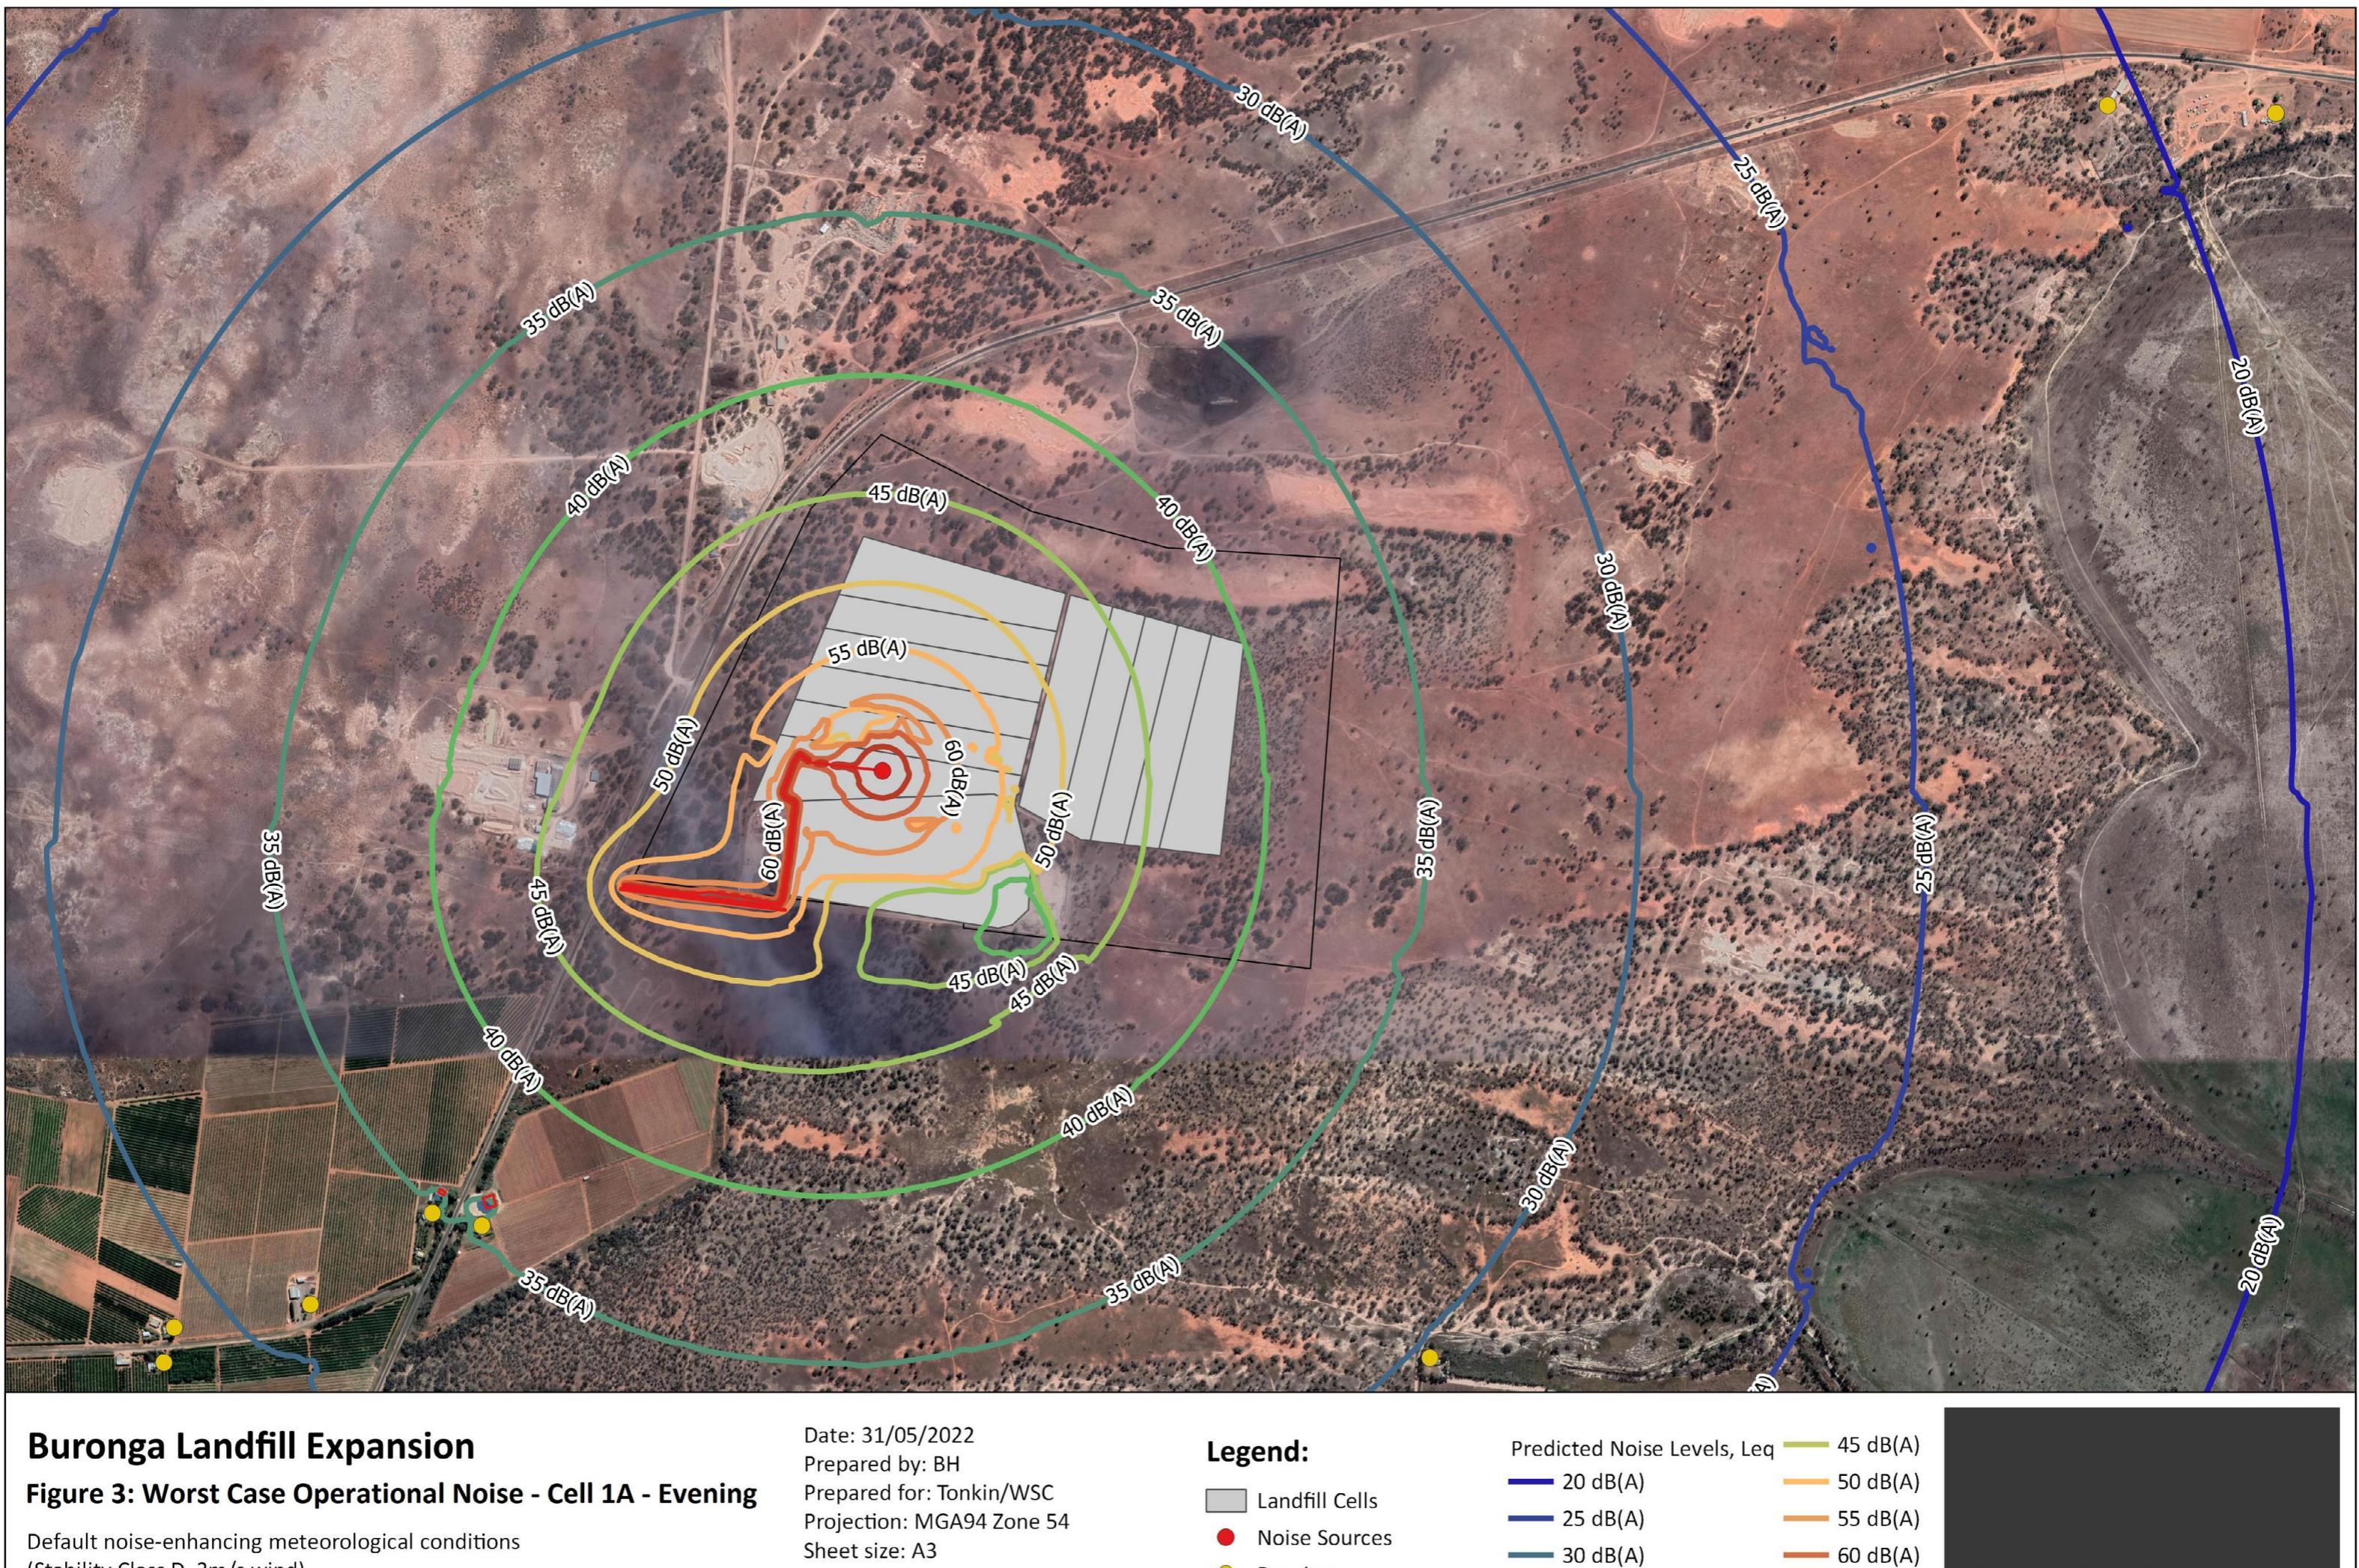
Default noise-enhancing meteorological conditions (Stability Class D, 3m/s wind) Includes 5dB character penalty

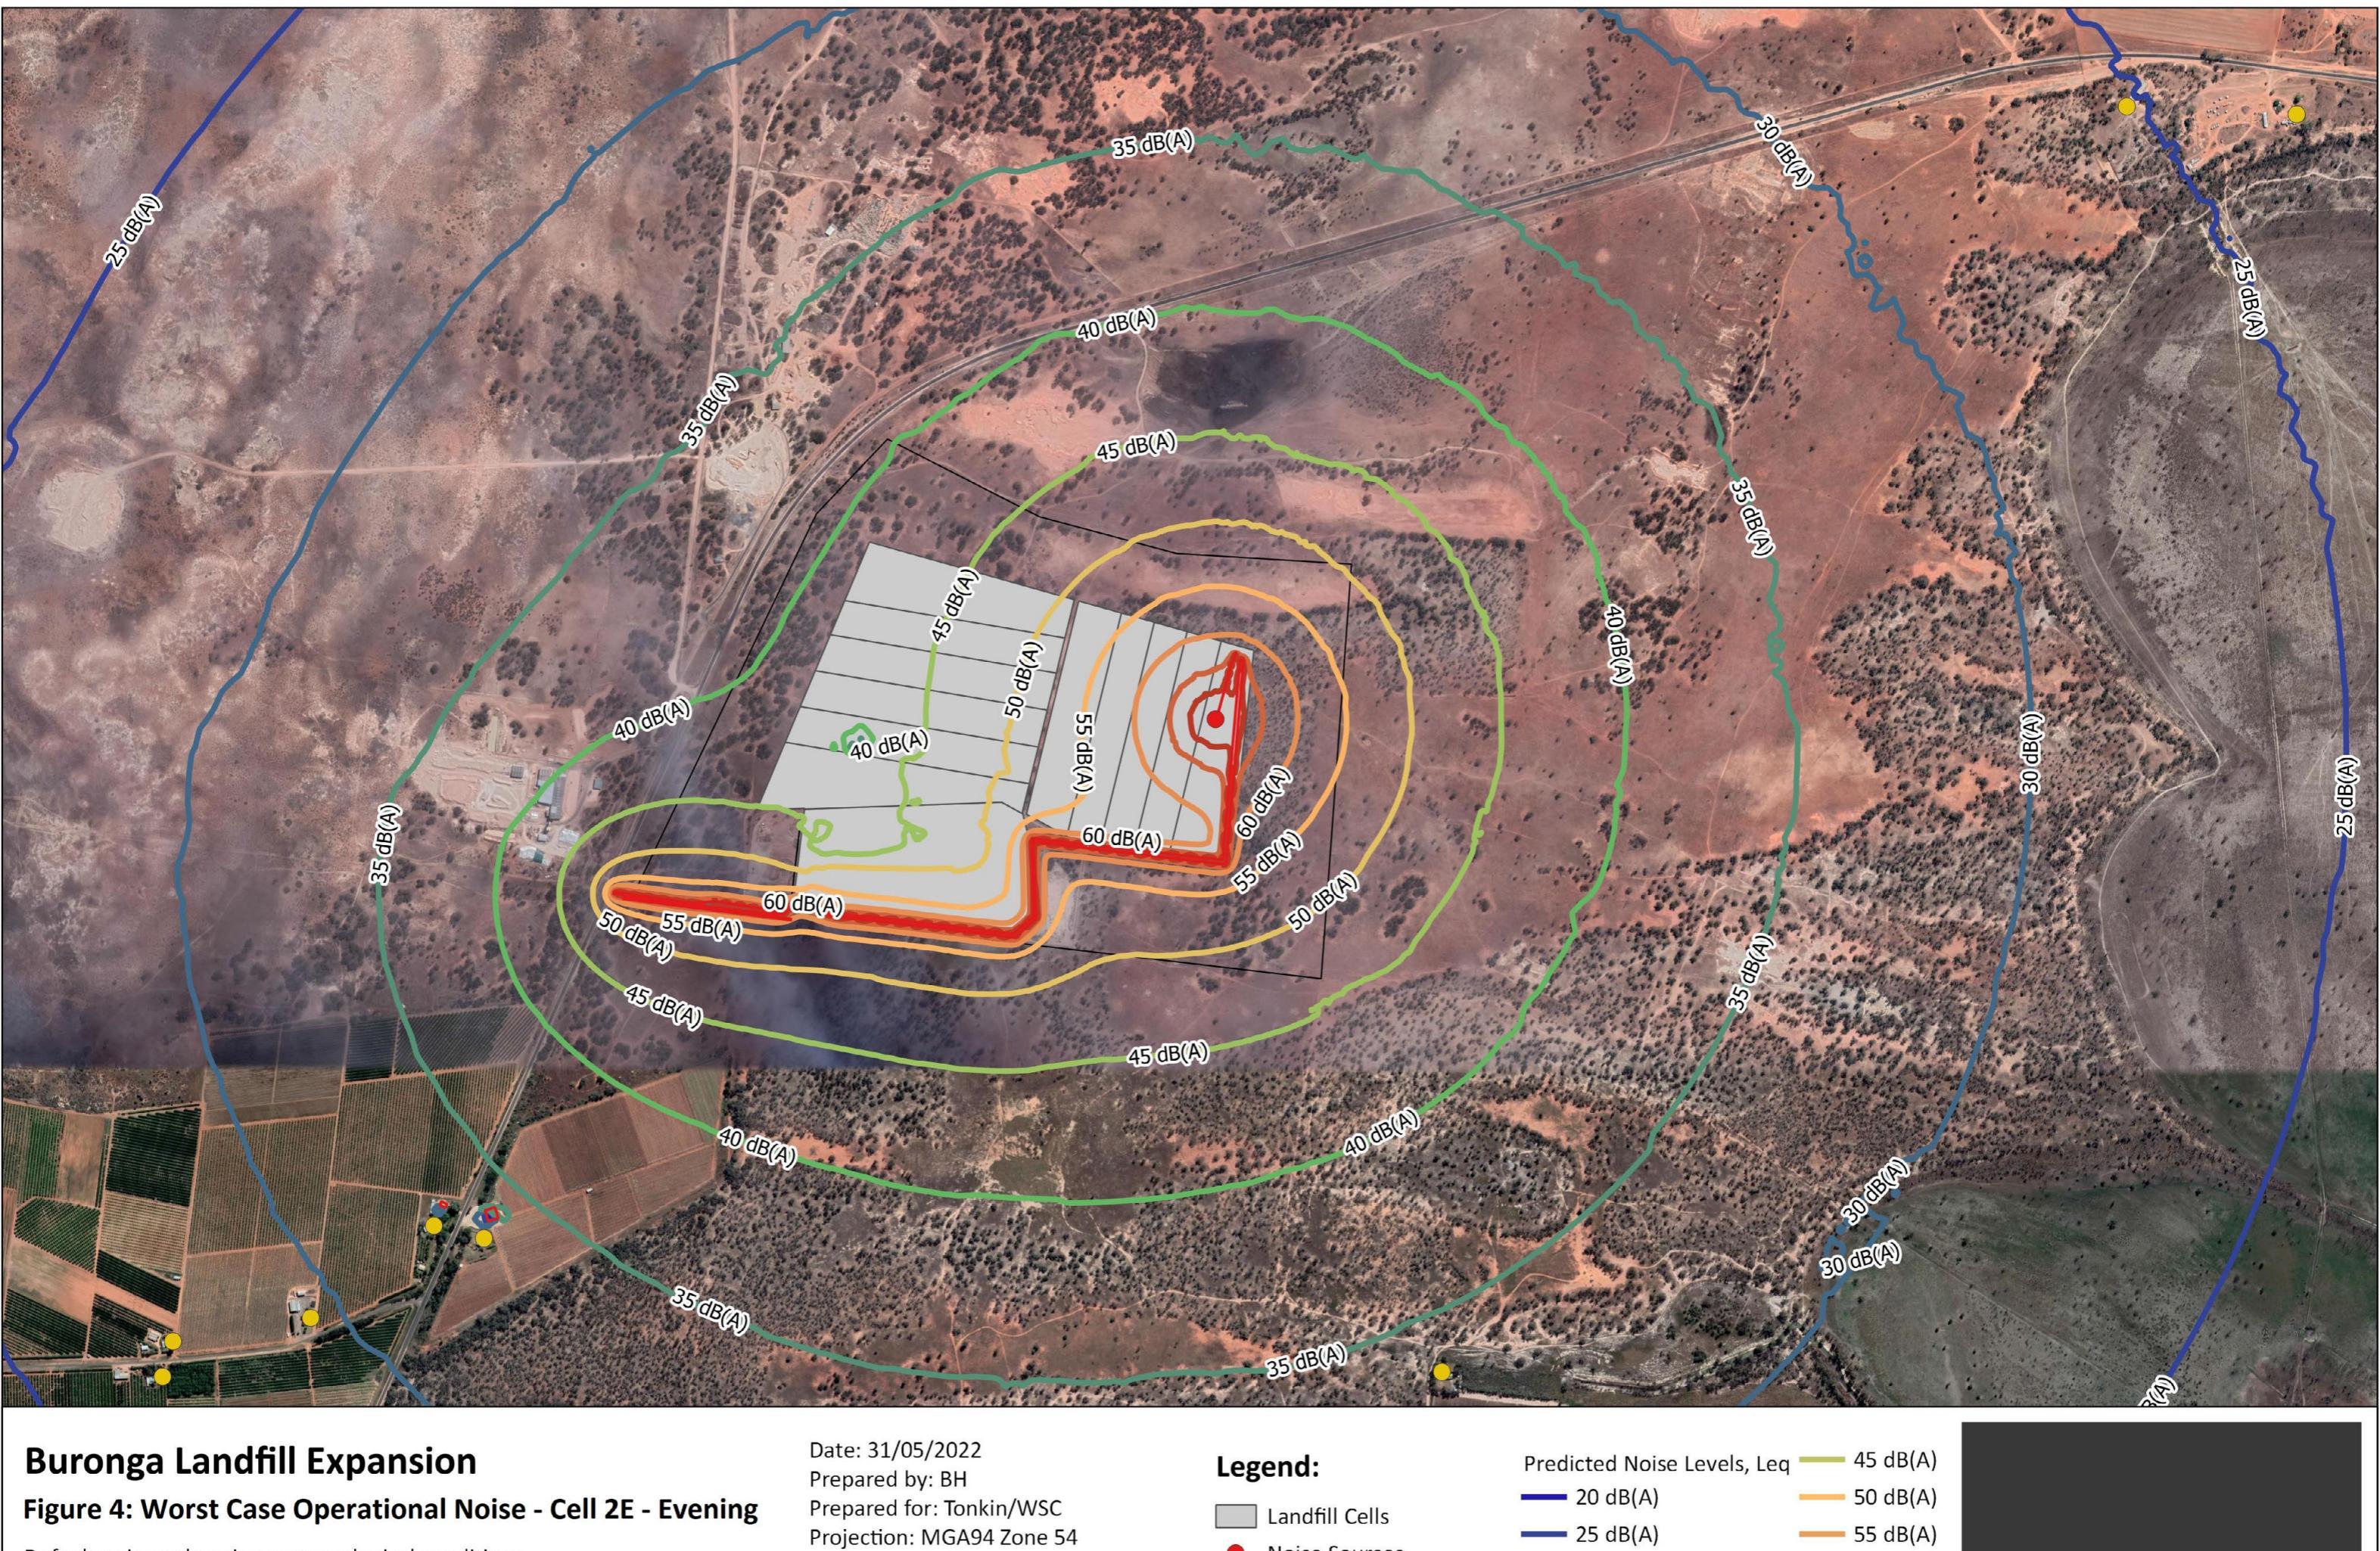
Default noise-enhancing meteorological conditions (Stability Class D, 3m/s wind) Includes 5dB character penalty
